NASA/TM-2015-218476

Analyses of Hubble Space Telescope Aluminized-Teflon Multilayer Insulation Blankets Retrieved After 19 Years of Space Exposure

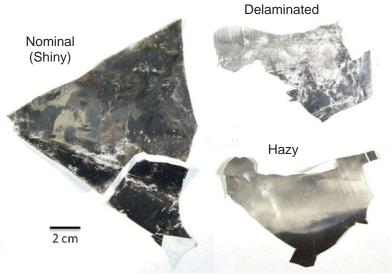
Figure 6.—Bay 8 nominal (shiny), hazy and delaminated MLI fragments.

The delaminated regions of Bay 5 and Bay 8 have very different physical appearances; therefore the delamination may not have been caused by the same factor. Bay 5 delaminated samples (an example is provided in Fig. 8) have a checkerboard-like pattern of delaminated areas on a surface with predominately retained Al backing. There is no tendency for more Al to flake off. In contrast, Bay 8 delaminated samples (an example is provided in Fig. 8) have small patches of Al distributed throughout a mostly delaminated surface and additional Al easily spalls off from the FEP on handling the samples.

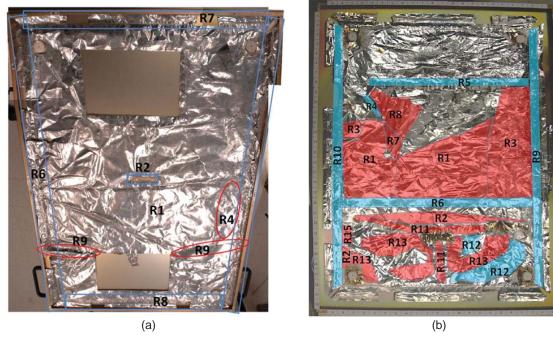
The retrieved Bay 5 and Bay 8 MLI blankets contained a range of unique regions that were identified based on environmental exposure and/or physical appearance and assigned numbers. For example, the Bay 8 MLI that was not covered by patch material and was exposed to the space environment for the full 19.1 years had areas with three distinct appearances: shiny areas ("nominal"), hazy-white areas and areas where the Al was delaminated. These regions were defined as Regions 8.1, 8.2 and 8.3 (R8.1, R8.2 and R8.3), respectively. Examples of these regions are provided in Figure 6. Also, as mentioned, one of the Bay 8 outer layer Al-FEP cracked areas (not covered by patch material) curled up into a cone-like roll. In the curled region, the backside Al was exposed to the space environment. This material was heated to a higher temperature on-orbit than the nominal space-facing FEP because of the lower emittance of the aluminized surface. The curled area was divided into two regions: a tightly curled region (R8.7) and a loosely curled region (R8.8), as those two regions may have heated differently on-orbit. This curling was not observed at SM3B, so the insulation was in the curled state for no more than 7.1 years. Some areas of the patches installed during SM2 eventually degraded exposing the underlying MLI to the space environment once again as observed during SM3B and SM4. Therefore, the MLI under the patched areas is divided into two regions: the region patched during SM2 and exposed by SM3B (SM2-SM3B, patched 5.1 years, called R8.13), and the region patched during SM2 and still covered at SM4 (SM2-SM4, patched 12.2 years, called R8.11).

Figure 7.—Photographs of Bay 5 and Bay 8 with exposure regions identified: (a) Bay 5, and (b) Reassembled Bay 8 (red regions were tested, blue regions were not).

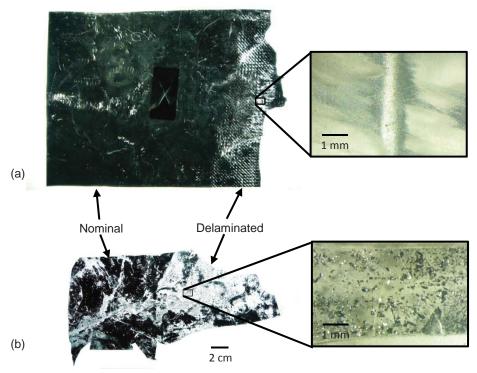
Figure 8.—Comparison of Bay 5 and Bay 8 shiny and delaminated regions: (a) A section of material cut from Bay 5, and (b) A cracked fragment of Bay 8 material (back lit photos).

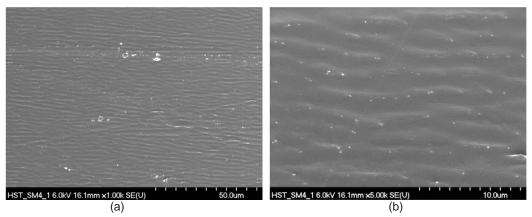
Figures 9 and 10 compare the space-exposed (FEP) surfaces of Bay 8 Region1 (nominal/shiny) and Bay 8 Region 2 (nominal/hazy) using the Hitachi S-4700. Atomic oxygen erosion has resulted in distinct textures in these two regions. The shiny material has fine, rill-like directional texturing, whereas the hazy material has larger rounded features. The difference in texture may be attributed to the hazy region being located near the top edge of the bottom patch, where it may have received additional shadowing and/or scattering of AO from the patch at various times in the orbit. EDS spectra of Regions 1 and 2 are shown in Figures 11(a) and (b), respectively. The spectra indicate that only C and F peaks, and very small Au and Pd peaks from the Au-Pd conductive coating, are present. There is no presence of Si, hence no indication of silicone contamination in the nominal/shiny region, nor in the hazy region. However, a barely detectable Si peak was detected on a Bay 8 Region 1 sample imaged with the Hitachi S-3500. Figure 12 shows the space-exposed (FEP) surface of Bay 8 Region 3 (delaminated). The FEP is clearly cracked in the delaminated region, and the texture appears to be less pronounced as compared to Regions 8.1 and 8.2. It is not known if the cracking occurred on-orbit or due to retrieval handling. The space-exposed FEP from Bay 8 Regions 7 and 11, and Bay 5 Region 1, are shown in Figures 13 to 15, respectively. Bay 8 Region 7, which became tightly curled on-orbit, looks similar in texture to Bay 8 Region 1 surfaces, with perhaps slightly less texture. The Bay 8 Region 11 surface, which was patched

Figure 9.—Space exposed FEP surface of Region 8.1 (nominal/shiny): (a) 1KX magnification (45° tilt), and (b) 5KX magnification (45° tilt).

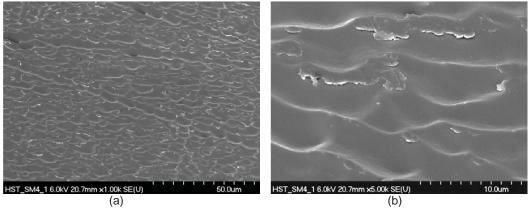
Figure 10.—Space exposed FEP surface of Region 8.2 (hazy): (a) 1KX magnification (45° tilt), and (b) 5KX magnification (45° tilt).

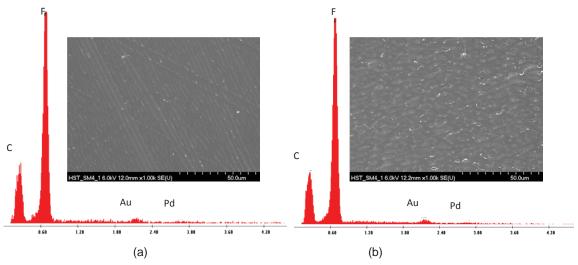
Figure 11.—EDS spectra and corresponding SEM image areas (0° tilt) of space exposed Teflon FEP surfaces: (a) Region 8.1 Nominal/Shiny, and (b) Region 8.2 Hazy.

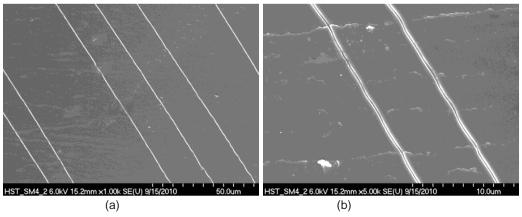
Figure 12.—Space exposed FEP surface of Region 8.3 (delaminated): (a) 1KX magnification (0° tilt), and (b) 5KX magnification (0° tilt).

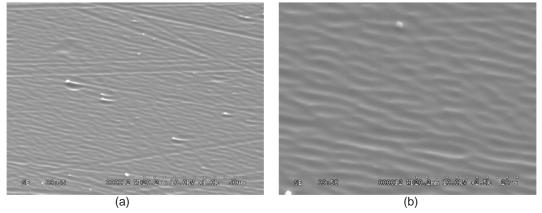
Figure 13.—Space exposed FEP surface HST SM4 Region 8.7 (tightly curled region): (a) 1KX magnification (45° tilt), and (b) 2.5 KX magnification (45° tilt).

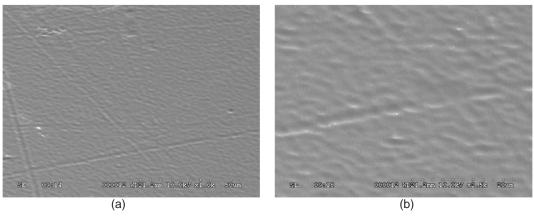
between SM2-SM4, has more rounded rill features, possibly due to receiving scattered AO from the patch. Both these surfaces had barely detectable Si peaks. As can be seen in Figure 15, the Bay 5 Region 1 surface has a different appearance than the Bay 8 surfaces. Whereas the Bay 8 surfaces eroded with a texture consistent with receiving grazing, or sweeping, AO exposure, the Bay 5 Region 1 surface showed little evidence of erosion with no notable erosion texture. This is consistent with thickness measurements, discussed later, which indicate that the Bay 5 material was eroded the least. The Bay 5 surface did show a larger Si EDS peak, indicating that there is some silicone contamination on this surface. This is consistent with the XPS analyses reported later.

Figure 14.—Space exposed FEP surface HST SM4 Region 8.11 (patched SM2-SM4): (a) 1KX magnification (45° tilt), and (b) 2.5 kX magnification (45° tilt).

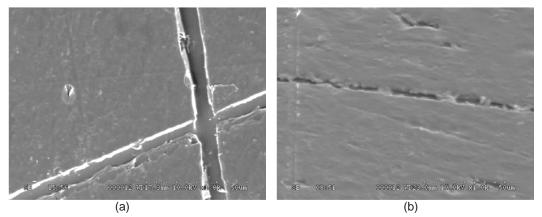
Figure 15.—Space exposed FEP surface of Region 5.1 (nominal/shiny): (a) 1KX magnification (0° tilt), and (b) 1KX magnification (45° tilt).

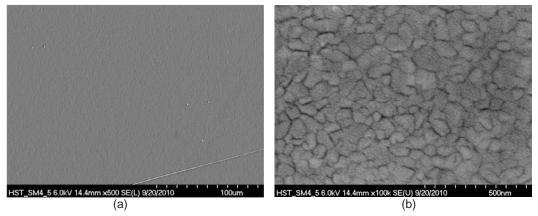
Figures 16 to 18 compare the aluminum surfaces of pristine Al-FEP, Bay 8 Region1 (nominal/shiny) and Bay 8 Region 2 (nominal/hazy) materials, respectively. The aluminum surface of the pristine Al-FEP is smooth with no cracks, as shown in Figure 16(a). At very high magnification (100KX) a grain structure can be seen as shown in Figure 16(b). As can be seen in Figures 17(a) and 18(a), the aluminum layer of the HST material is cracked, with more cracks (smaller islands) present in the hazy region (18a). Cracking of the Al layer can be attributed to the stress caused during thermal cycling because of the difference in the coefficient of expansion between Al and FEP (Ref. 4). Another interesting observation is the apparent growth of microscopic crystals in the aluminum surface, as shown in Figures 17(b) and 18(b), as compared to the pristine Al-FEP in Figure 16(b).

Figure 16.—Aluminum backing of pristine Al-FEP: (a) 500X magnification (0° tilt), and (b) 100KX magnification (0° tilt).

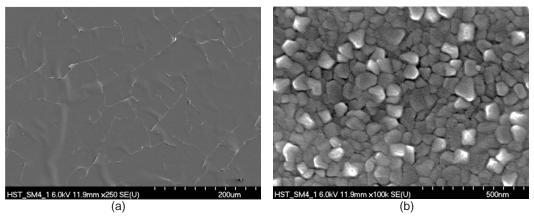
Figure 17.—Aluminum backing of HST SM4 Region 8.1 (nominal/shiny): (a) 250X magnification (0° tilt), and (b) 100KX magnification (0° tilt).

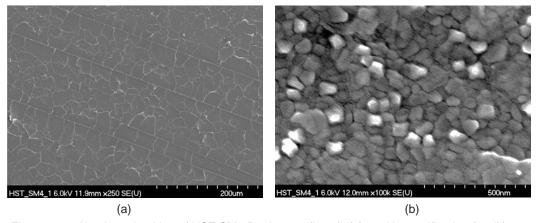
Figure 18.—Aluminum backing of HST SM4 Region 8.2 (hazy): (a) 250X magnification (0° tilt), and (b) 100KX magnification (0° tilt).

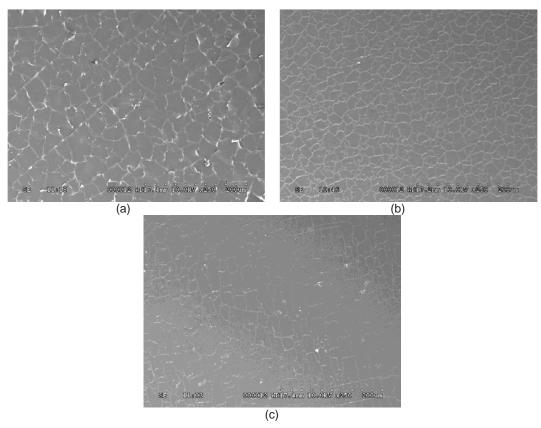
Images of the aluminum backing of Bay 8 Region 7, Bay 8 Region 11 and Bay 5 Region 1 are shown in Figures 19(a) to (c), respectively. The Bay 8 Region 7 surface has more mud-tiling than Bay 7 Region 1, and appears similar to the extent of mud-tiling of Bay 8 Region 2. The Bay 8 Region 11 surface, patched between SM2 and SM4, had the most extensive, finiest, mud-tiling. It was determined that this region received a higher temperature on-orbit with the patch in place. Bay 8 Region 7 also experienced a higher temperature on-orbit, but the curling was estimated to begin after SM3B, and hence had excessiving heating for a maximum of 7.1 years, and the tightly curled region would have been heated the least (at the bottom of the curled region). Bay 8 Region 11 would have received intense heating for approximately 12.2 years. The Al backing of the Bay 5 Region 1 material had more mud-tiling compared to Bay 8 Region 1. It appeared similar to the extent of mud-tiling of Bay 8 Region 2 or Bay 8 Region 7. The maximum on-orbit temperature of the Bay 5 Region 1 MLI was estimated to be less (0°) than that of the Bay 8 Region 1 MLI (40°), so the extent of mud-tiling is not easily explained.

Figure 19.—Aluminum backing (250X, 0° tilt) of: (a) HST SM4 Region 8.7 (tightly curled region), (b) HST SM4 Region 8.11 (patched SM2-SM4), and (c) HST SM4 Region 5.1 (nominal/shiny).

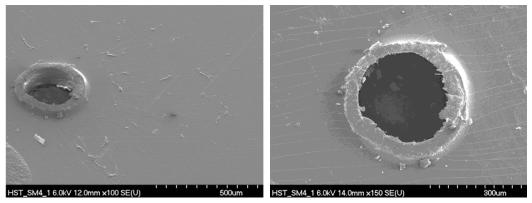
Several micrometeoroid and orbital debris (MMOD) impact sites were observed on the HST material. A typical impact site is shown in Figure 20, with fine cracking of the FEP layer visible near the impact site.

Figure 20.—An MMOD impact site in Bay 8 Region 1.

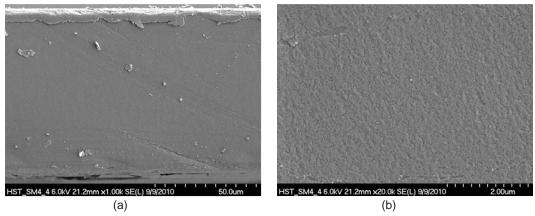
SEM micrographs show very clear differences in the morphologies of on-orbit formed cracks (Fig. 21) and post-flight handling formed cracks (Fig. 22). Handling cracks have fibrous features typical of ductile failure. However, the fracture surfaces of on-orbit cracks were very smooth. Similar observations were made on material retrieved during SM2, and this supports a slow crack growth mechanism in which on-orbit fractures propagate slowly under relatively low stresses, influenced by radiation and thermal cycling (Ref. 4).

Figure 21.—Edge on view of an on-orbit formed crack in HST SM4 Region 8.1 FEP (nominal/shiny) showing a smooth texture: (a) 1KX magnification, and (b) 20KX magnification.

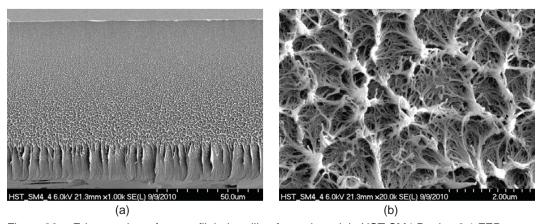
Figure 22.—Edge on view of a post-flight handling formed crack in HST SM4 Region 8.1 FEP (nominal/shiny) showing a fibrous texture: (a) 1KX magnification, and (b) 20KX magnification.

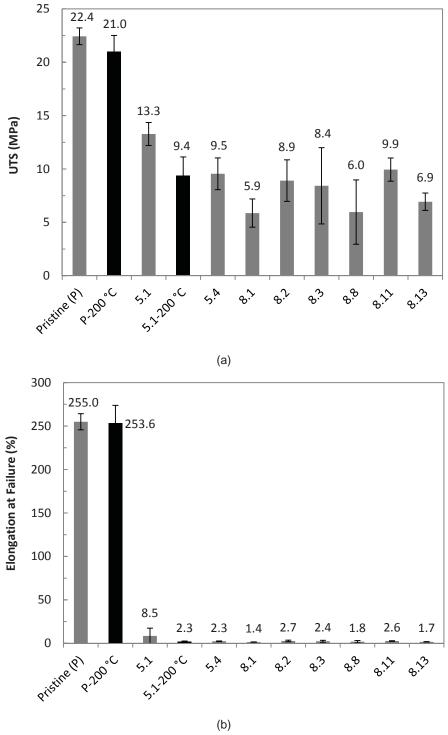
All HST material was extremely embrittled. Elongation at failure was reduced from 255 percent for pristine material to 8.5 percent for Bay 5 nominal/shiny material and to 1.5 percent for Bay 8 nominal/shiny material. The Bay 8 Al-FEP, which had a significantly higher solar exposure and on-orbit thermal cycling temperature, was found to fracture very easily with handling, like thin brittle glass. All regions also experienced large decreases in UTS, from 22.4 MPa for pristine Al-FEP to 13.3 and 5.9 MPa for Bay 5 and Bay 8 nominal/shiny material, respectively. Although the standard deviation is large compared to some of the absolute values, both the UTS and the elongation at failure appear to correlate with the amount of solar exposure received. For example, the solar facing Bay 8 material is more embrittled than the solar grazing Bay 5 material, and the elongation at failure of Bay 8 material is proportional to the amount of time that it was patched.

Figure 23.—Tensile properties of pristine and HST Al-FEP: (a) Average UTS and (b) Average elongation at failure.

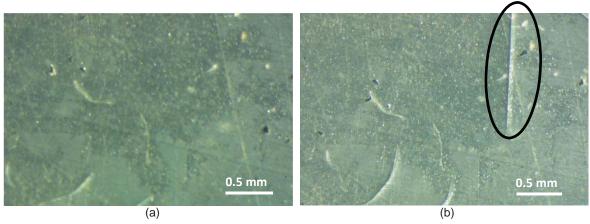
Figure 24.—A sample from Bay 5 Region 1 (a) before and (b) after bend-testing with the bend-test-induced crack circled.

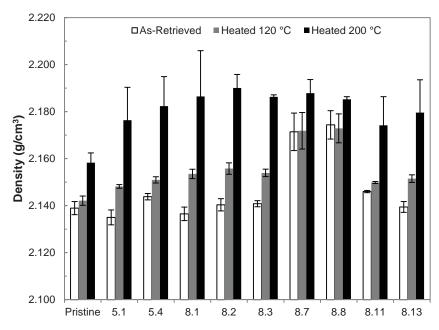
The densities for all measured regions of HST Al-FEP and pristine material are provided in Table 5 and graphed in Figure 25. With the exceptions of R8.7 (tightly curled), R8.8 (curled), R8.11 (patched), the density of as-retrieved material did not vary significantly from pristine material (2.140 g/cm³). Most exposure regions (besides R8.7, R8.8 and R8.11) only reached an estimated maximum temperature of 40 °C, which is too low to allow for crystallization, so no change in density was observed. A large change in density (to 2.174 g/cm³) was observed for the curled regions, which has previously been shown to be a result of the higher on-orbit temperatures experienced in these regions (Refs. 8 and 10). At elevated temperatures chain mobility increases, allowing more polymer chains to align into the compact, crystalline state, increasing both percent crystallinity and density, as further discussed (Refs. 8 and 10).

Figure 25.—Density of as-received, 120 and 200 °C heated samples. Error bars indicate the standard deviation.

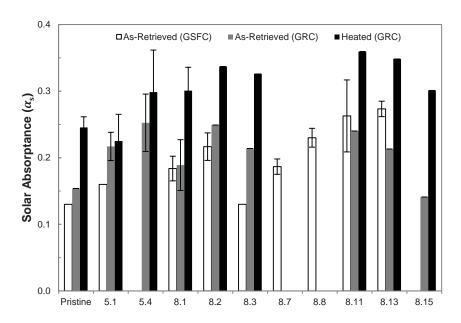
The as-retrieved and 120 °C-heated solar absorptance values obtained at GSFC and GRC are provided in Table 6 and graphed in Figure 26. It should be noted that the pristine Al-FEP absorptance obtained at GRC (0.15) was slightly higher than the value obtained at GSFC (0.13). This is attributed to calibration differences between the two instruments; hence comparisons should only be made between data taken on the same instrument. As-retrieved samples from both GSFC and GRC experienced an increase in solar absorptance compared to pristine Al-FEP, with the exception of Bay 8 Region 3 (delaminated region), which was measured at GSFC without an inner layer. The GSFC absorptance of Bay 5 was slightly higher (0.16) than pristine Al-FEP (0.13), while Bay 8 had a wide range of absorptance values, with the greatest absorptance for Bay 8 Region 13 (0.27). This is the region that was patched between SM2 and SM3B, and then exposed again to space. The data trends for absorptance changes are consistent for both GSFC and GRC, with the Bay 8 hazy-white region (Region 2) and the patched regions (Regions 11 and 13) having the greatest increases in solar absorptance.

Figure 26.—As-retrieved and 120 °C heated solar absortpance values.

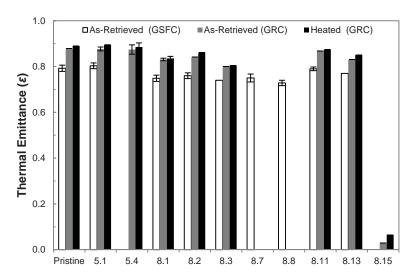
The as-retrieved and heated thermal emittance values obtained at GSFC and GRC are provided in Table 7 and graphed in Figure 27. The GSFC thermal emittance values were found to decrease for all samples except Bay 5 Region 1 and Bay 8 Region 11 (the region patched between SM2 and SM4). Emittance loss is typically associated with thickness loss of FEP, but for Bay 8 Regions 7 and 8 (the curled regions), samples may have experienced additional emittance change due to excessive heating onorbit. Similar to the GSFC emittance values, the GRC emittance was found to decrease for all samples except Bay 5 Region 1 (also Bay 5 Region 4) and Bay 8 Region 11, the region patched between SM2 and SM4. Heating had little impact on the emittance values of the retrieved HST MLI.

Figure 27.—As-retrieved and heated emittance values.

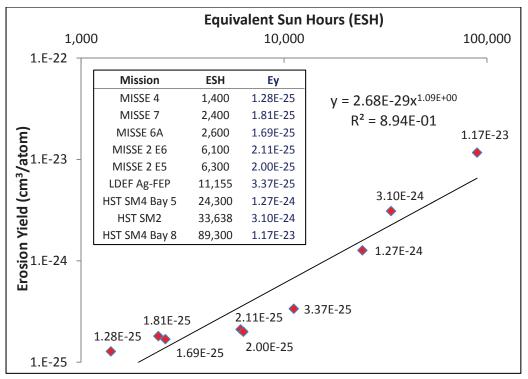
The Ey values of Teflon FEP from various missions including MISSE 2, MISSE 4, MISSE 6, the Long Duration Exposure Facility (LDEF) and space exposed multilayer insulation retrieved from HST during the second servicing mission (SM2) are provided in Table 10, along with the Ey values for HST SM4 Bay 5 and Bay 8. Included in the table are the space exposure duration, solar exposure, AO fluence and AO exposure arrival. These Ey values were plotted in numerous ways including: Ey versus AO fluence, Ey versus time, Ey versus ESH and Ey versus ESH/AO ratio. The best fit was found for Ey versus ESH, and the corresponding graph is shown in Figure 28. It should be noted that although the best fit was found for Ey versus ESH, it is likely that temperature plays a critical role in the erosion process.

Figure 28.—Erosion yield versus ESH for Teflon FEP flown from various missions.
